Biogenic sulfuric acid corrosion resistance of MasterSeal 7000 CR

Report no. 20220927A

**Fraunhofer Institute for Environmental, Safety,
and Energy Technology UMSICHT**

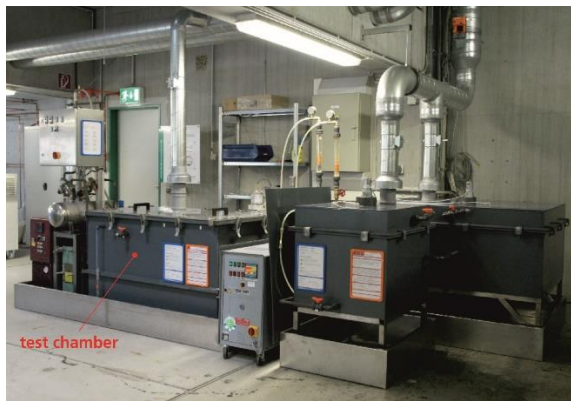
Figure 1 Test facility at Fraunhofer UMSICHT.

The test facility used for the weathering is located at Fraunhofer UMSICHT and operated by Fraunhofer UMSICHT. Figure 1 shows the test facility and the connected test chambers. In this project the chamber on the left-hand side was used to carry out the weathering test.

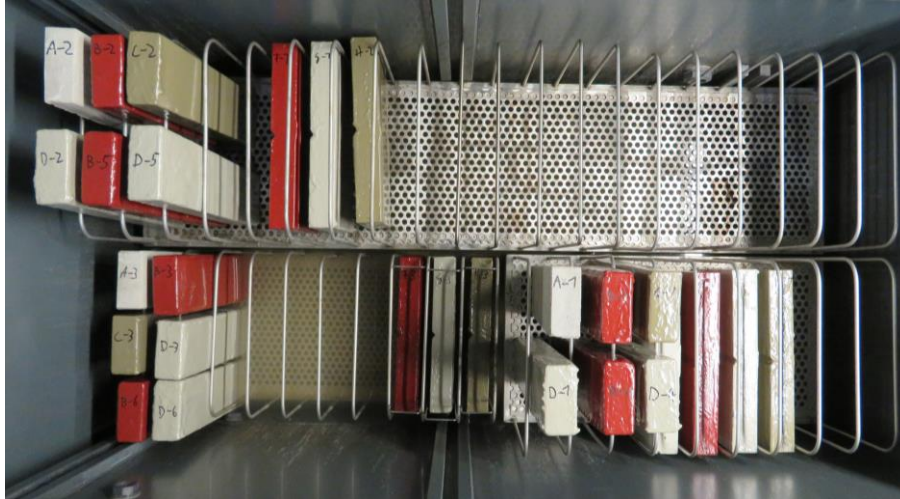
Figure 4 Placement of concrete specimens and polymer films. Specimens of MasterSeal 7000 CR are the ones in red colour. The specimens in other colours have been provided by Master Builders Solutions Deutschland GmbH for additional testing and comparison.

The concrete specimens were placed in the bottom of the chamber using a rack made of stainless steel. In figure 4 the placement of the concrete specimens is shown.

The polymer films were placed above the concrete specimens in a rack made of PVC (s. figure 4). The films were placed on sheets of artificial turf (polypropylene) to avoid an all-area contact with the PVC rack and were covered with small frames made of polycarbonate to avoid movement.

Placement of concrete specimens

Platform with polymer foils with frames of carbonate

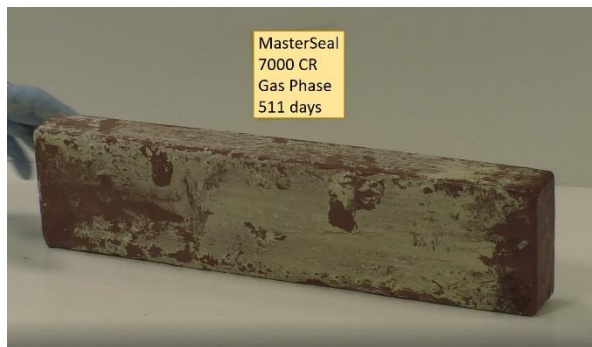
Specimen after 511 days testing.

After visual inspection, abrasion resistance test and adhesion test on specimens stored 511 days in the weathering chamber at the Fraunhofer UMSICHT, no reduction of properties of MasterSeal 7000 CR were observed.

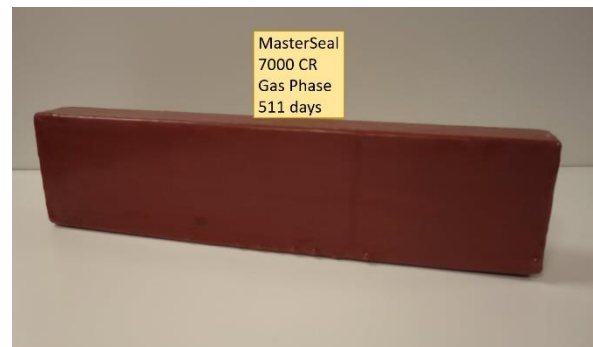
Specimen after 511 days testing and cleaning.

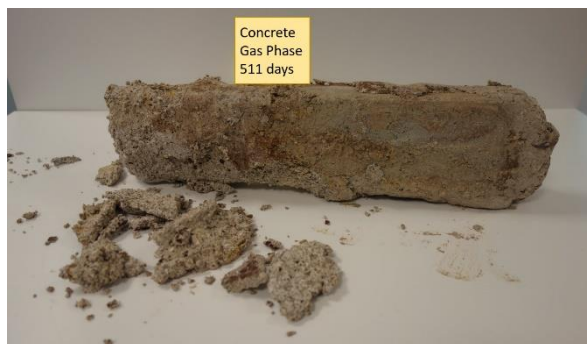
Specimen after 511 days testing.

The highest cell numbers of the remaining strongly acidophilic sulfur oxidizers were detectable on uncoated test specimens exposed in the gas space of the test, which appeared visually heavily corroded after completion of the test with comparatively low sulfur loads on the surfaces (approx. $115 \mu g cm^{-2}$).

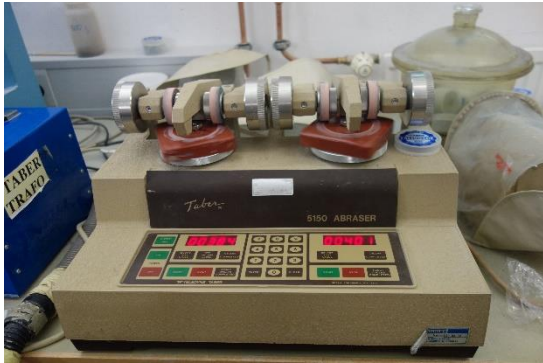
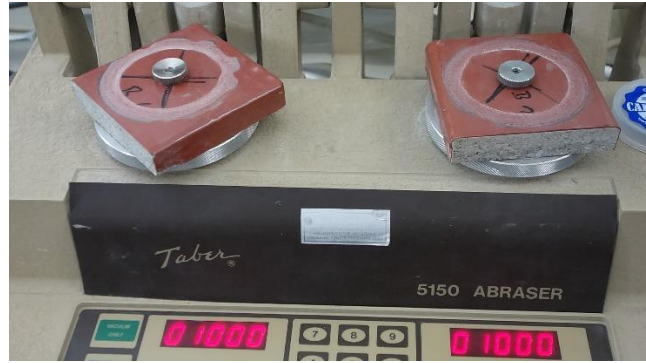
3. Abrasion resistance of MasterSeal 7000 CR: Taber test – after 511 days testing

Testing in accordance with EN ISO 5470-1
Weight loss after 1000 cycles: 220 mg (Required: < 3000 mg)

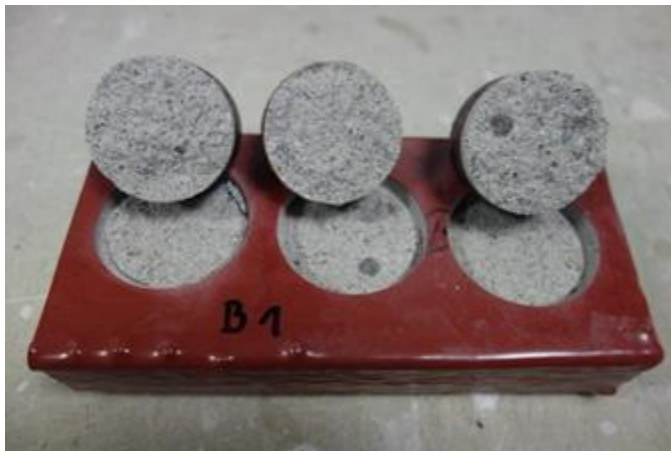
4. Adhesion of MasterSeal 7000 CR after 511 days testing

Testing in accordance with EN 1542
Adhesion to concrete: 3.1 MPa – failure in the concrete
